PERRYDALE PROJECT FILE:

Project: The re-fitting of Dreamer

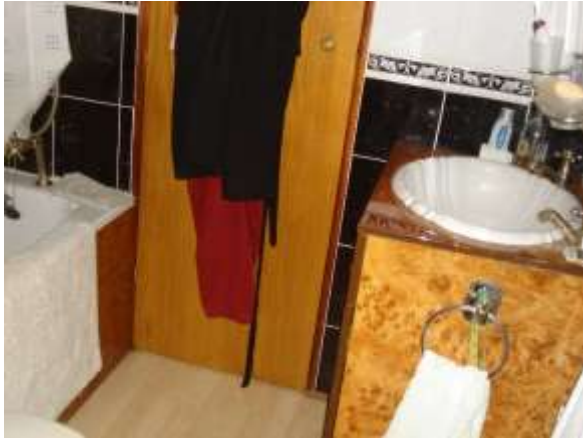
Before

Space in the original walk through bathroom was limited by the presence of a full sized bath. The owner's restricted mobility made this difficult to use. It was therefore replaced by a cross over walk through with plenty of space for dressing and a large quadrant shower for easy access and use.

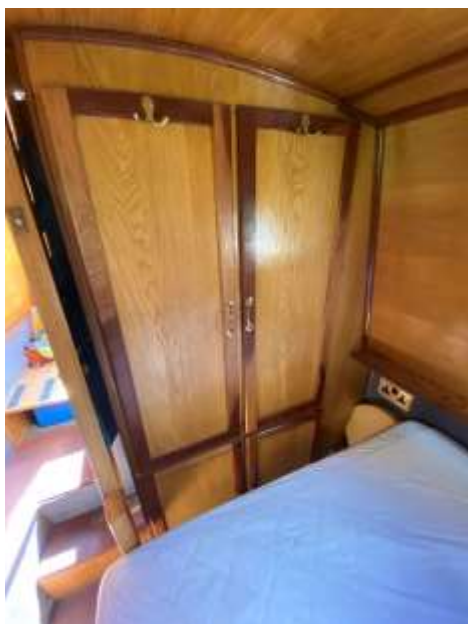
Before

With the exception of the panels and floor, little was to change in the bedroom. However the owners found that the original wardrobe doors would not fully open as the bed was in the way. Perrydale subsequently replaced these with concertina doors and added a new overhead cupboard above the bedhead to match.
