PERRYDALE PROJECT FILE:

Project: The re-fitting of Dreamer

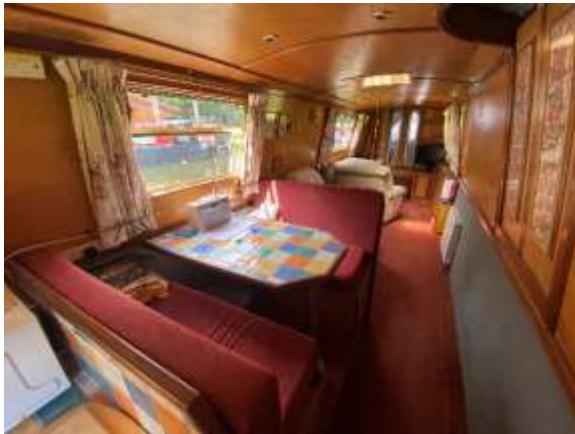
Before

The front section of the saloon then remained the same. The existing stove and fireplace were untouched but a modern unit was added opposite. New steps were fitted to include a pull out step to assist with better access. Feature handles were added on the side panel for extra assistance.
